Memorandum

Date: *August 15, 2014*

Subject: *Oversight Summary Report
CPG Oversight of RM 10.9 Removal Action
Lower Passaic River Restoration Project*

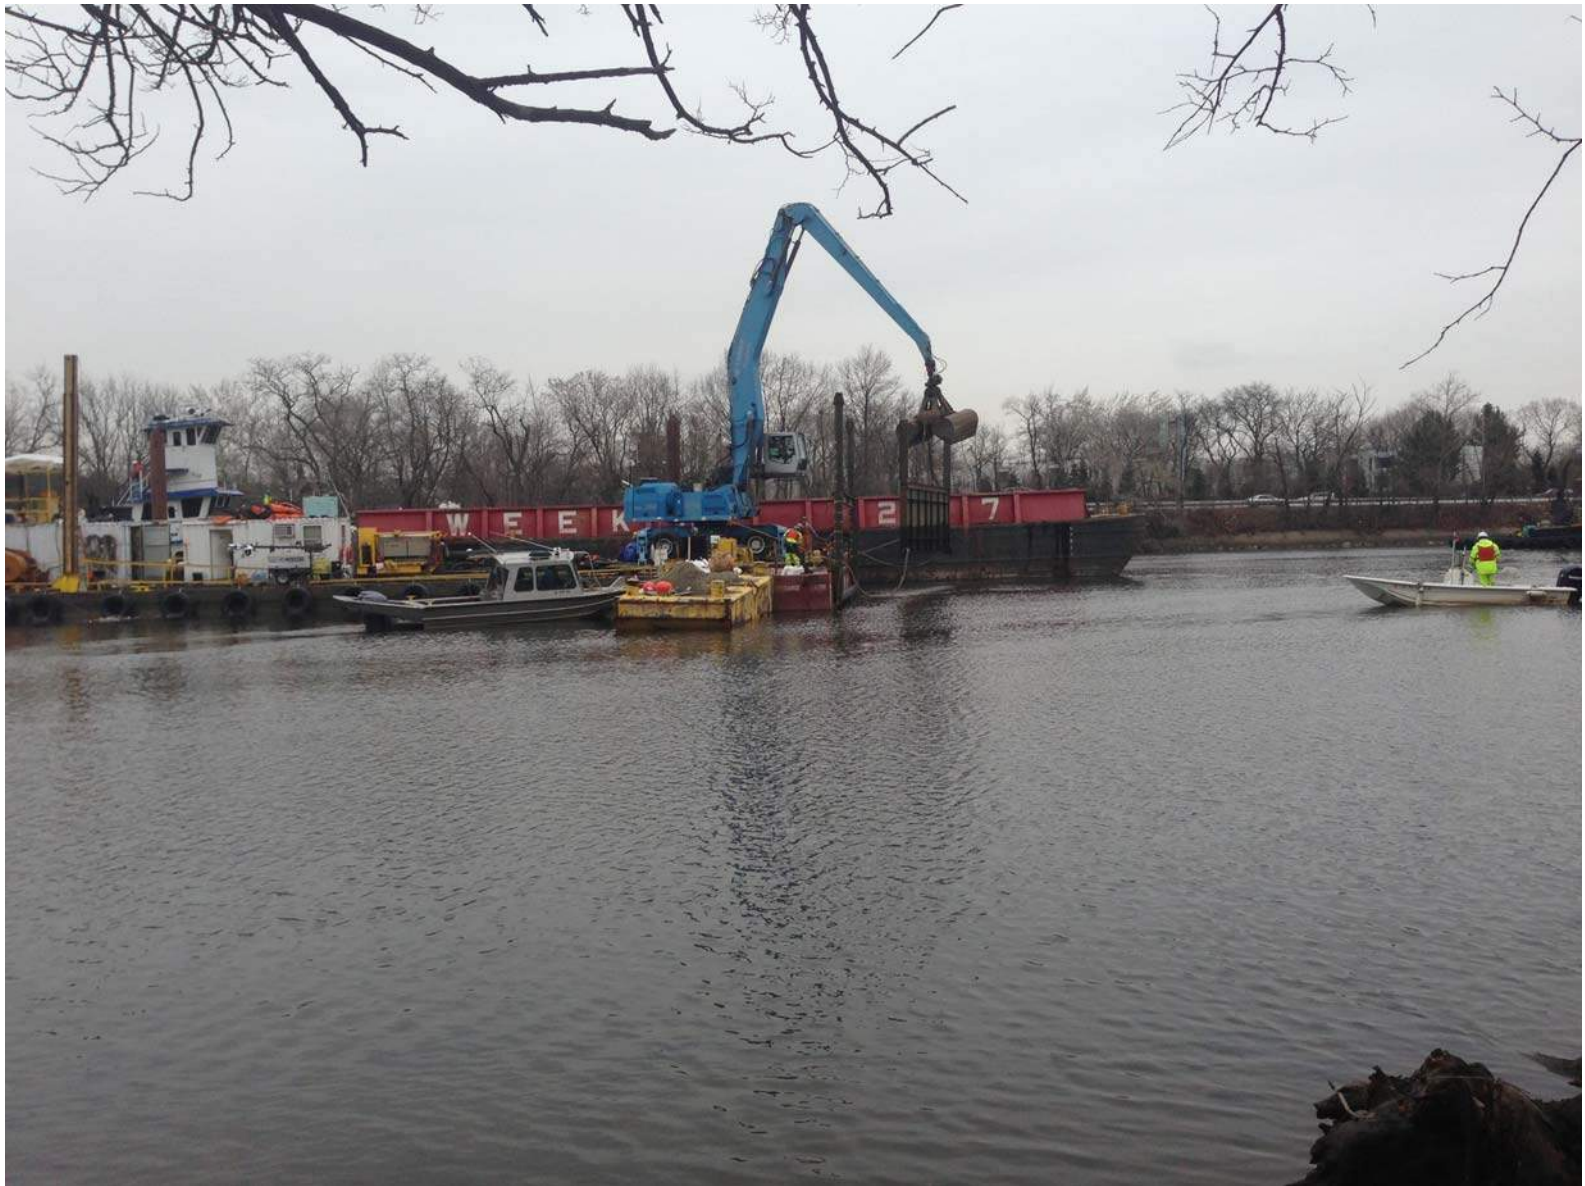
Fabric Chute

The unfinished fabric chute, shown from the side.

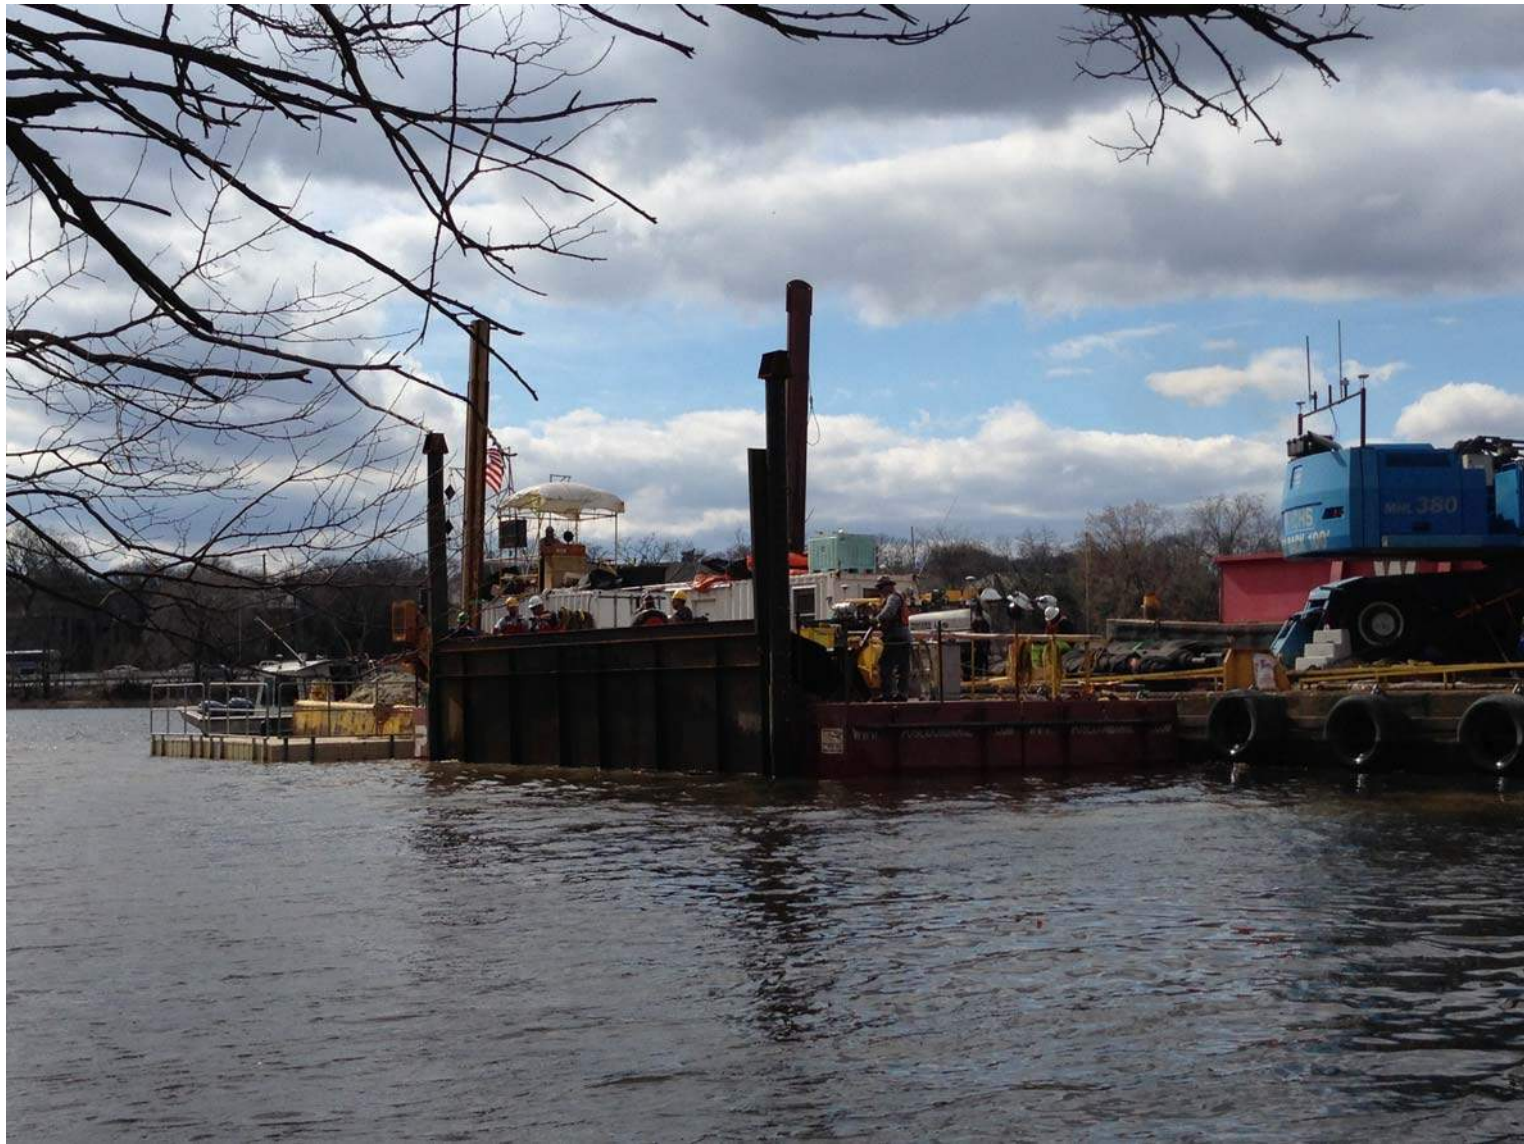
Installation of Panel 00-N with Fabric Shroud

The installation procedure is mostly unchanged. The difference is that, instead of exposed fabric passing vertically through the water column, it is now inside a casing that mitigates the effect of the river current. The assembly is raised and lowered using the winch system.

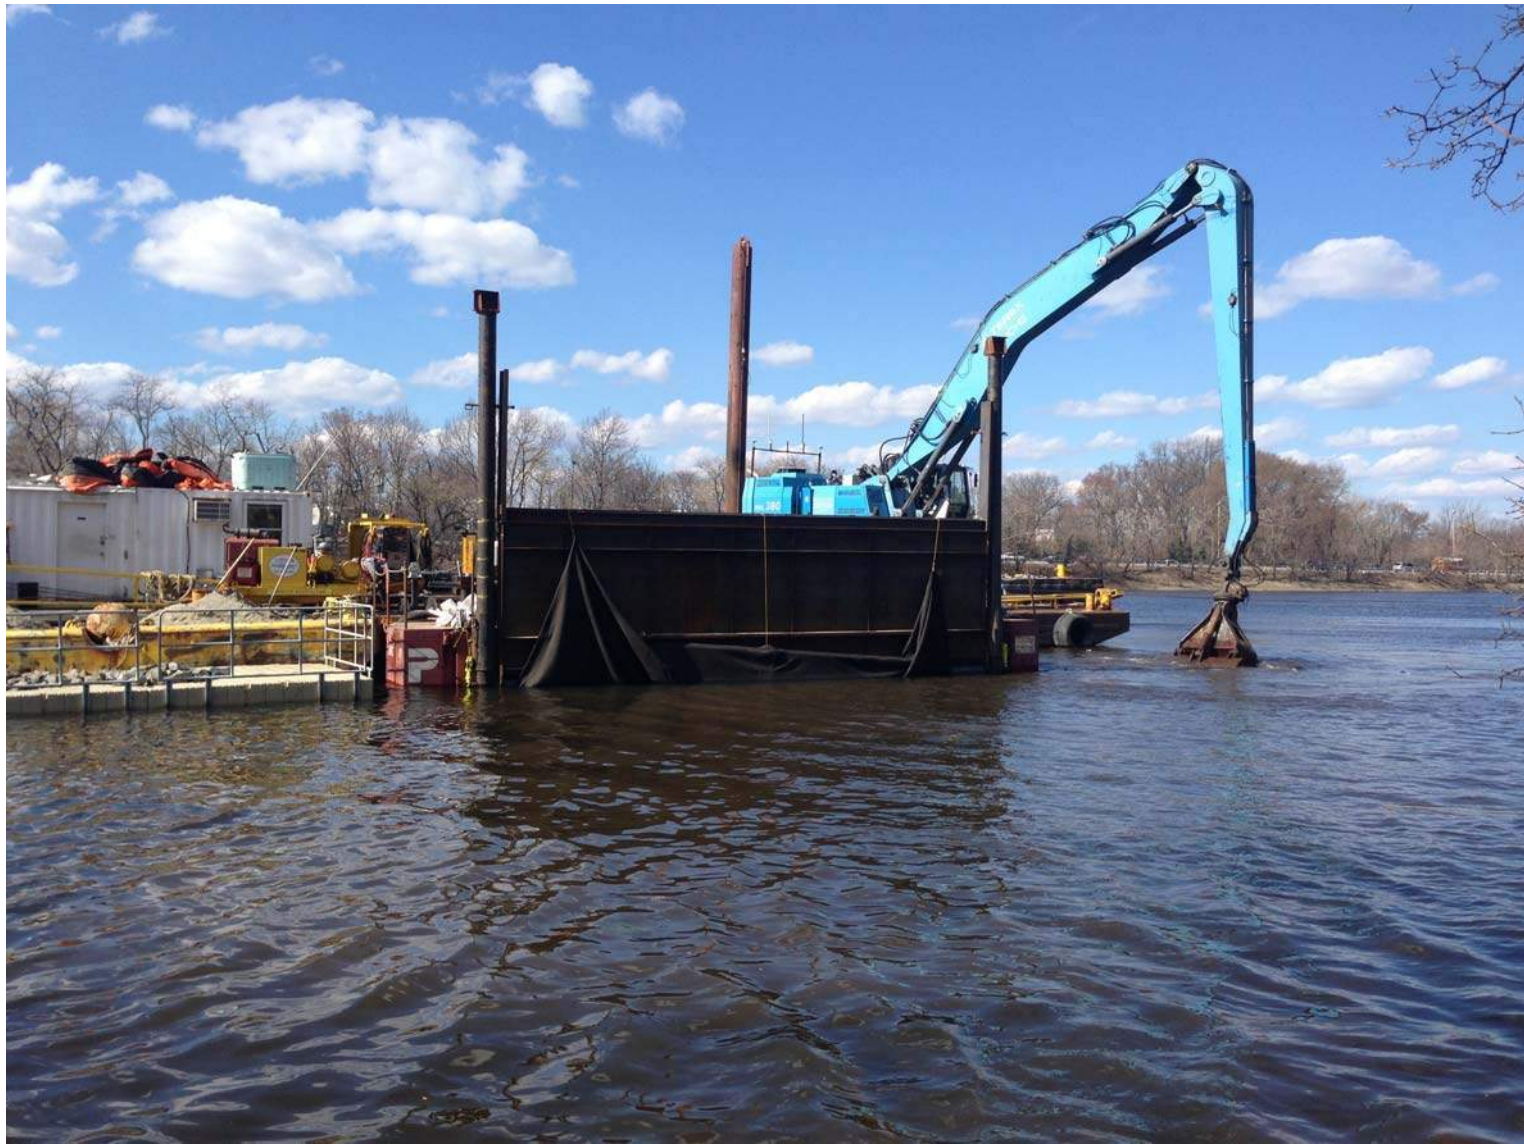
Fabric Shroud Setup Pre-Installation

The geotextile fabric panel passes through the top of the fabric shroud, then out the bottom. There is a rolling bar at the bottom, similar to the sinking bar assembly. Installation begins by placing the two corners (shown above) at the desired location and applying armor stone.

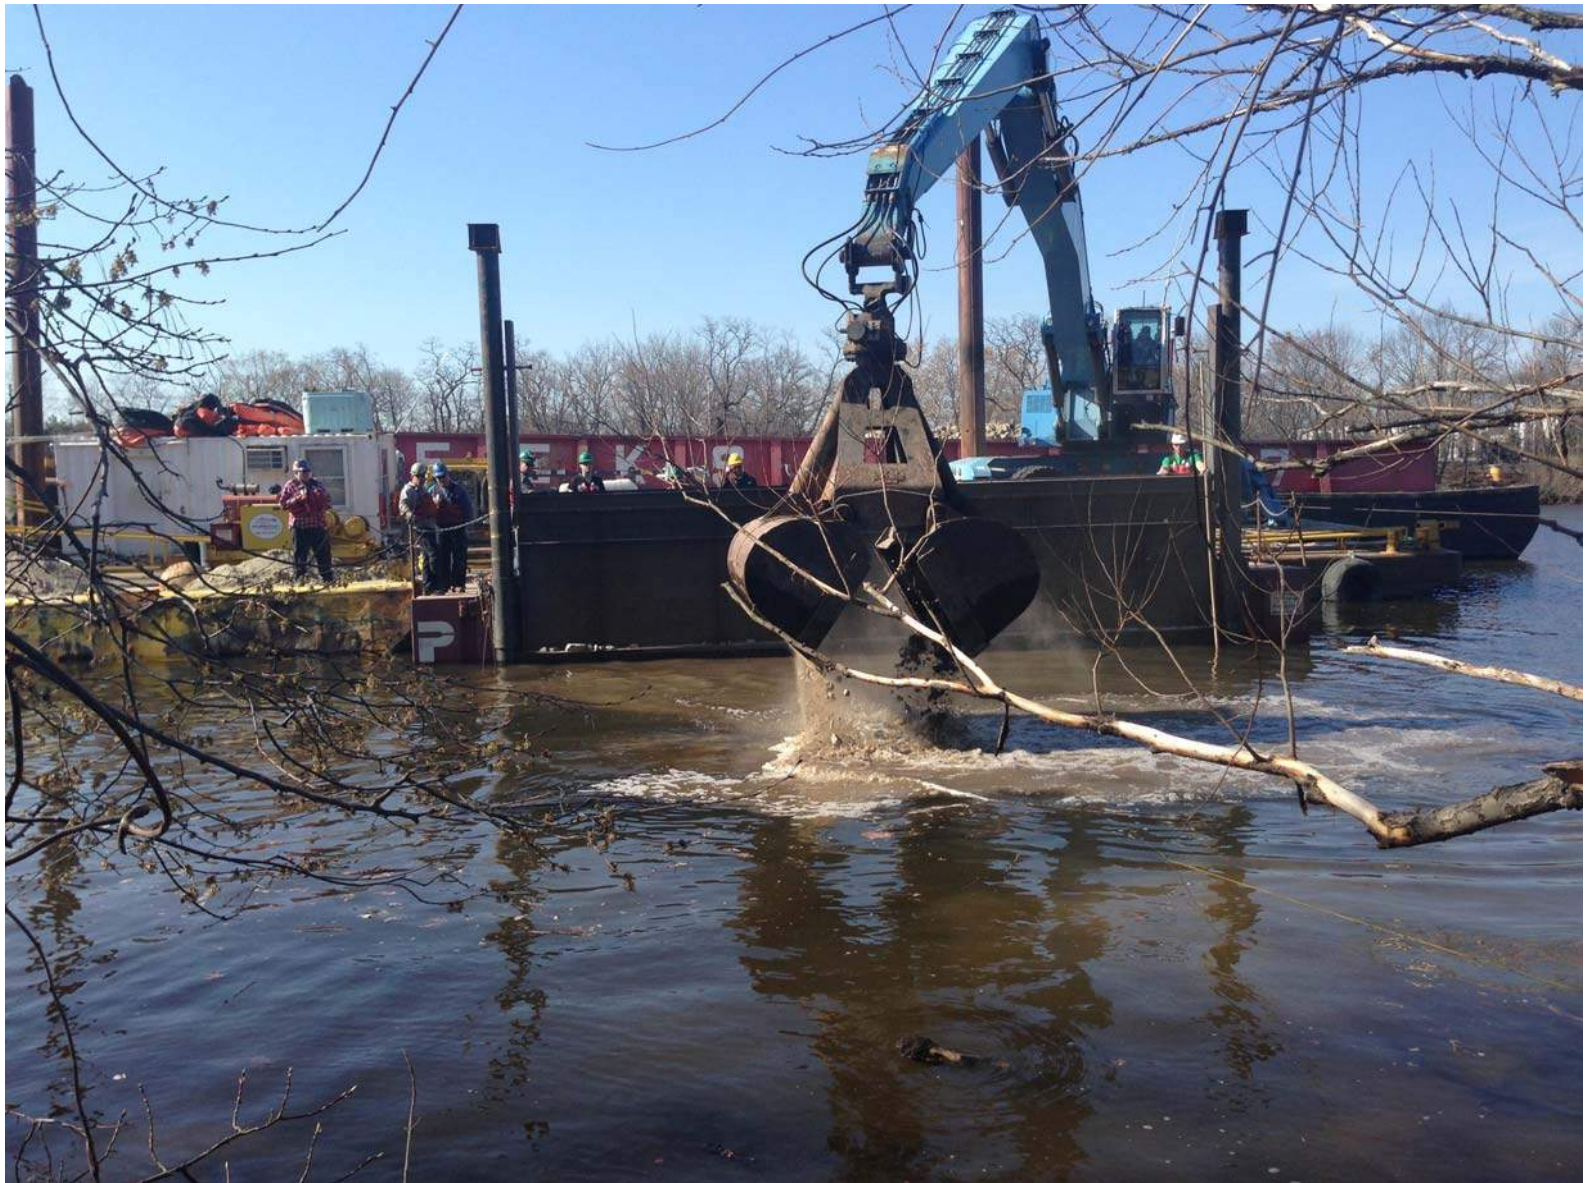
Type B Stone at Panel 31-S

The smaller “Type B” armor stone was applied atop the first 20-30 feet of geotextile panel, over the high subgrade area.

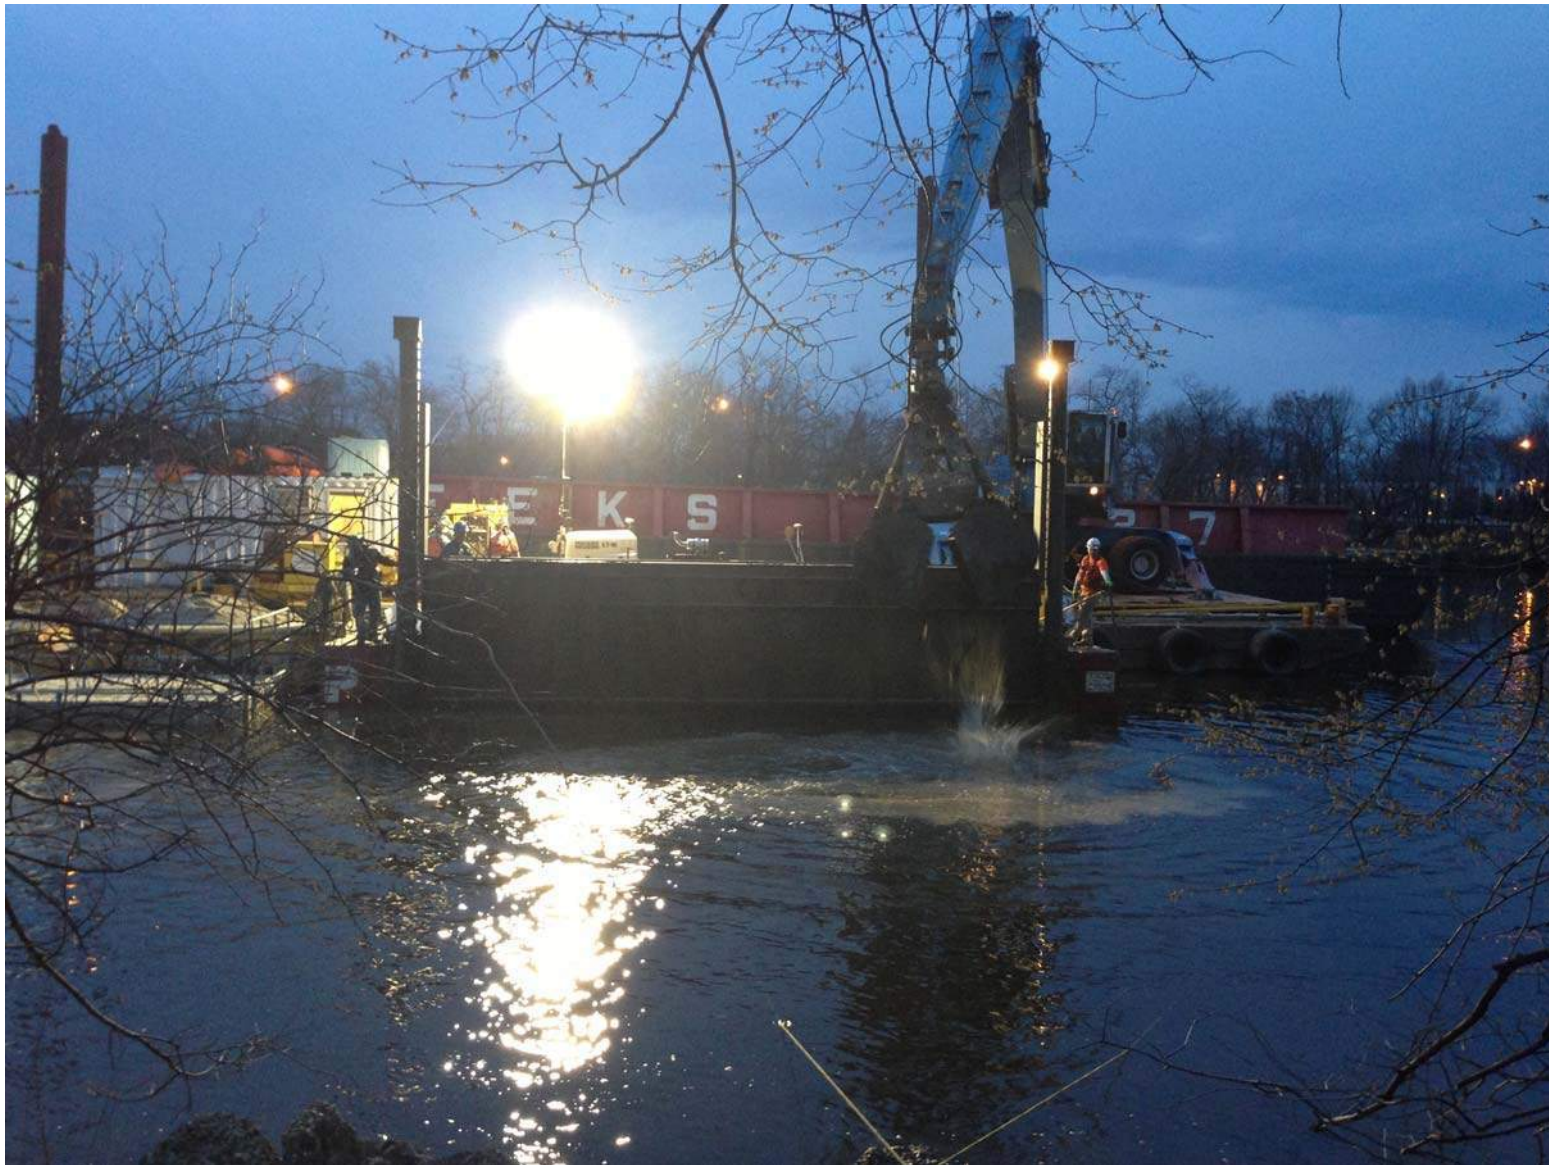
Panel 30-S Installation

Geotextile fabric panel 30-S was installed at high tide in the morning. Type B armor stone was used in the high-subgrade areas.

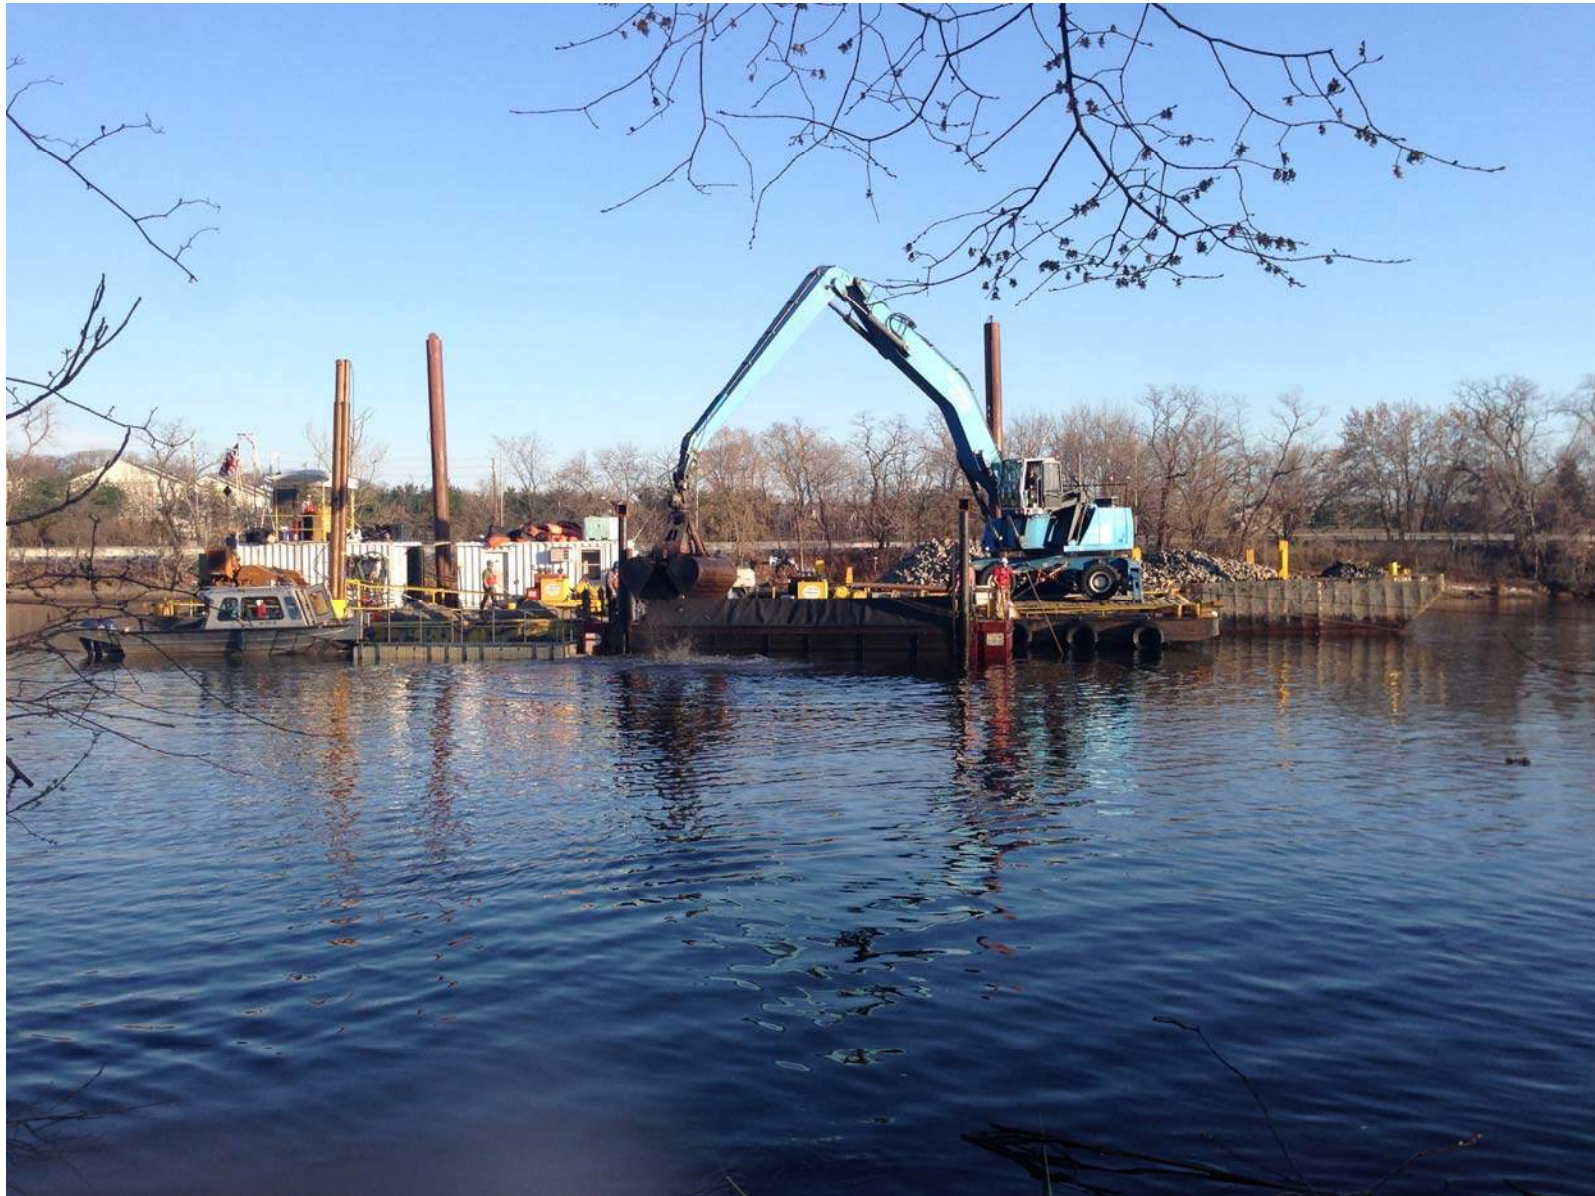
Saturday, April 12th, Panel Installation

GLDD successfully installed two geotextile panels. Each required approximately one hour and twenty minutes.

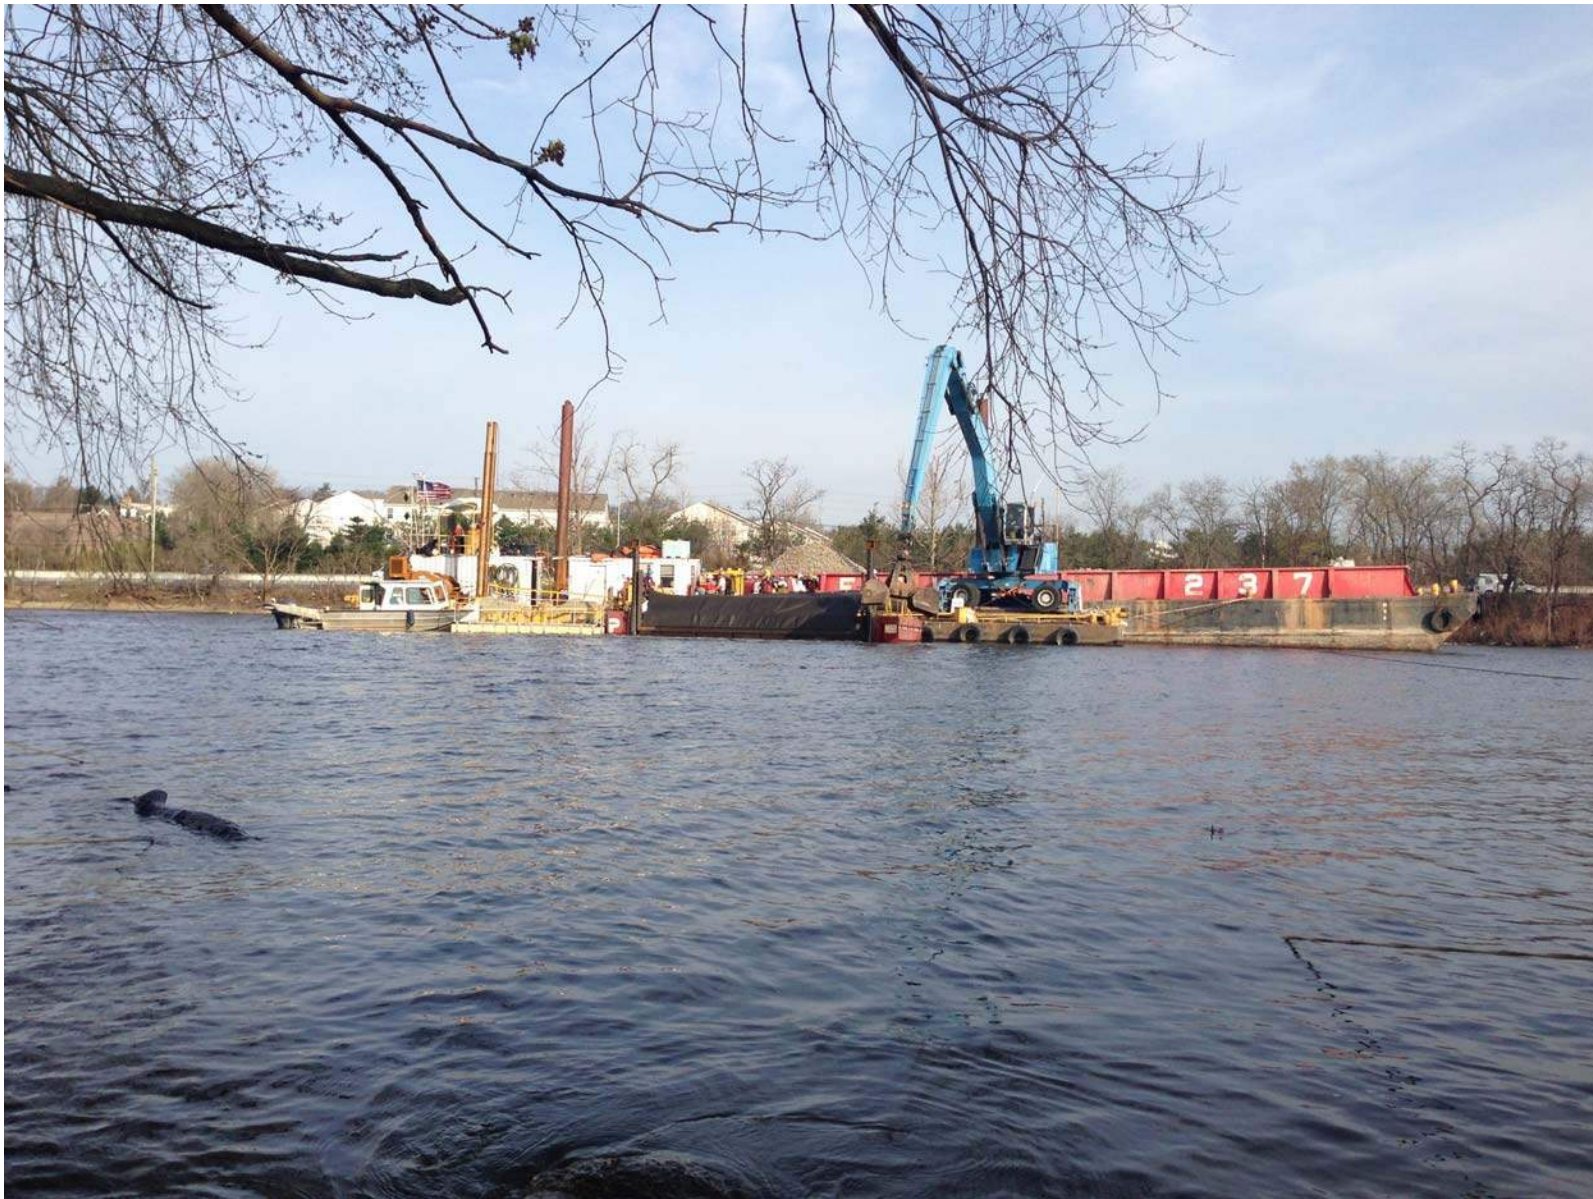
Geotextile Panel 25-S Installation

GLDD successfully installed three geotextile panels in the morning. Over two feet of overlap were observed between adjacent panels.

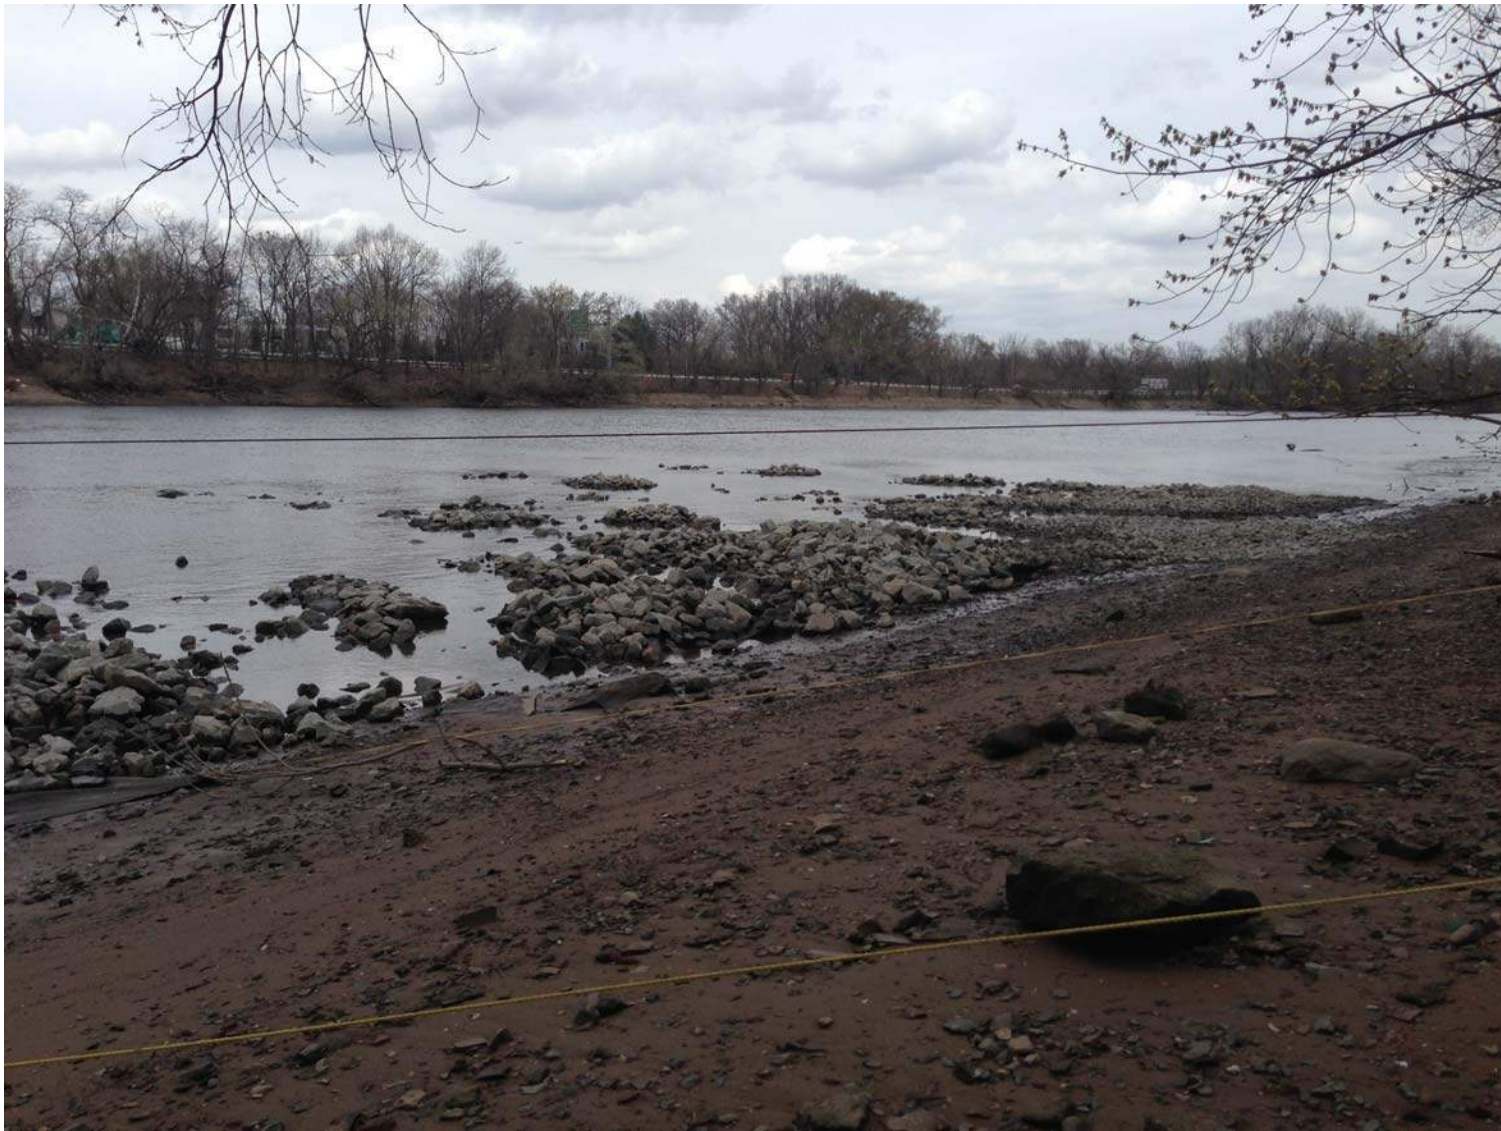
Armor Stone at Low Tide

The armor stone atop the recently-placed geotextile panels was visible as the tide went out in the early afternoon. The farthest away stone (note that it is “Type B” stone) is immediately south of the No Dredge Zone. There are visible low spots that will need to be revisited.

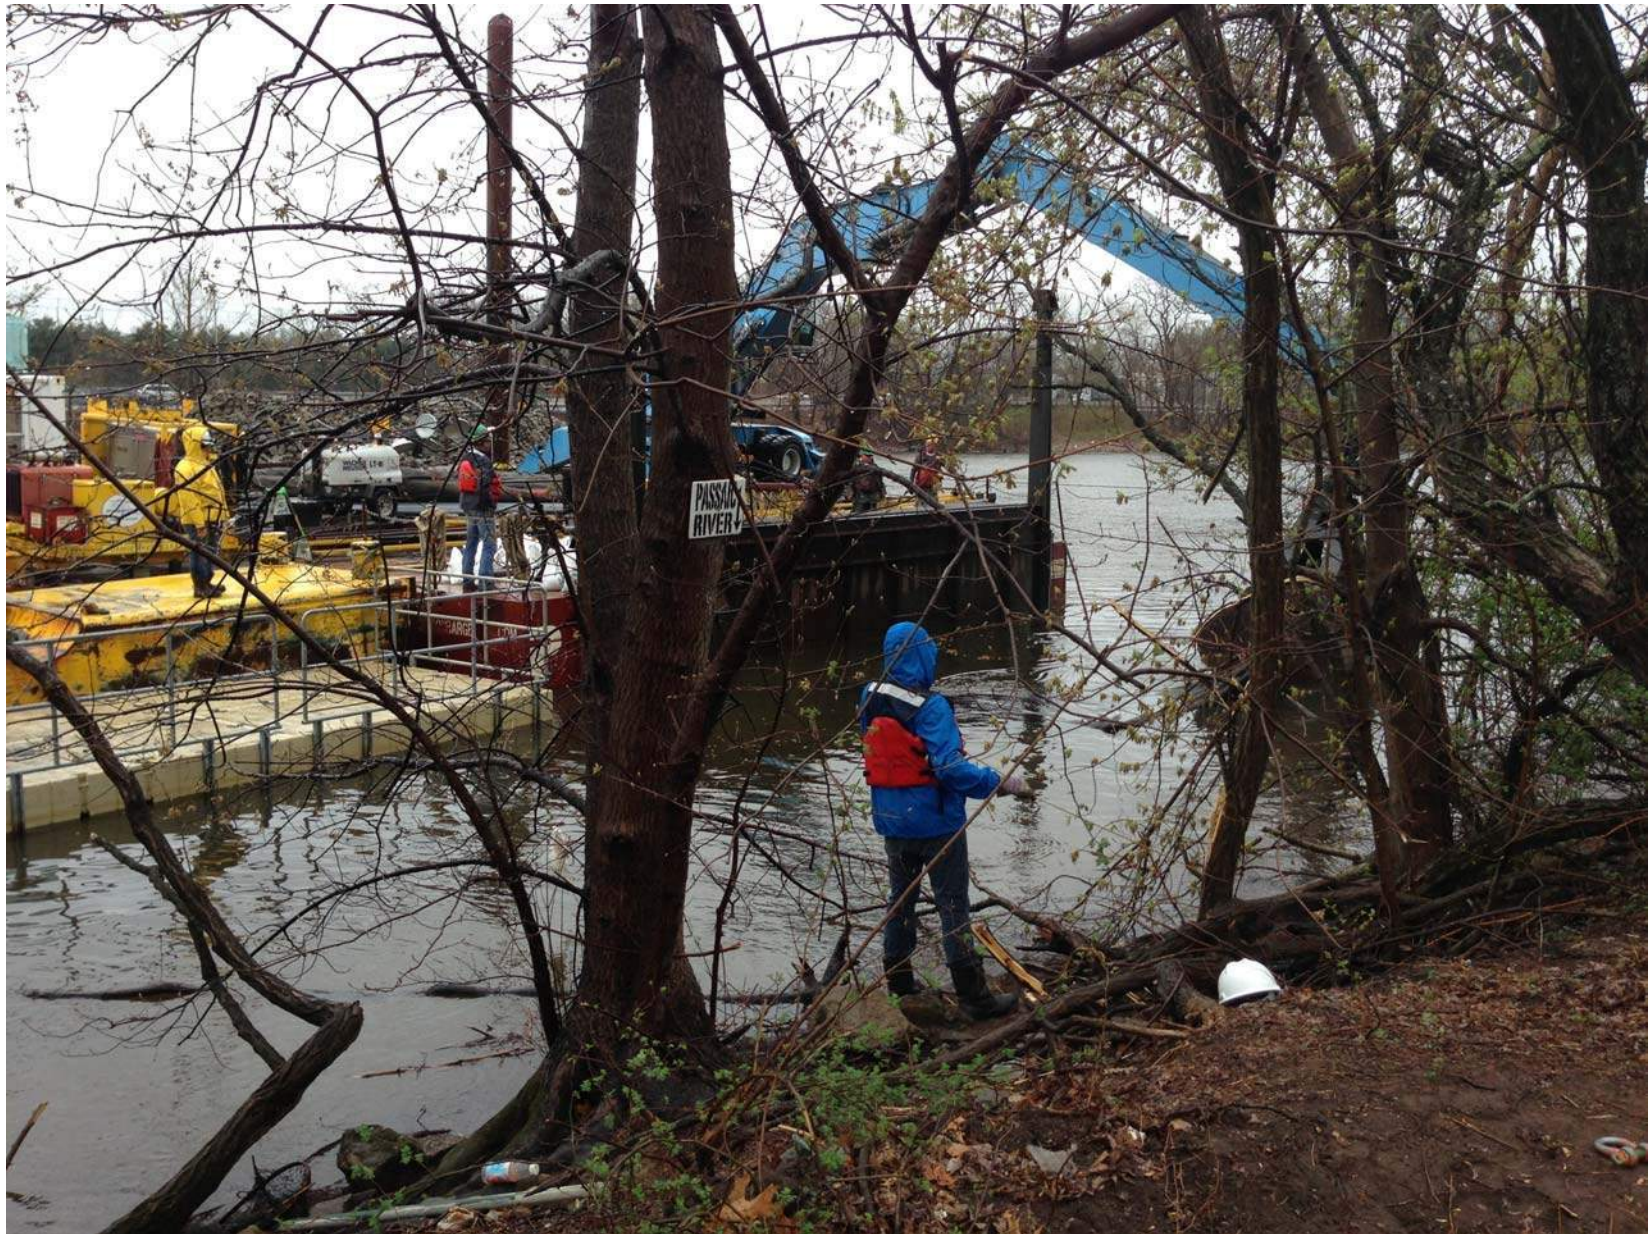
Geotextile Panel 21-S Installation

GLDD successfully installed two geotextile panels despite rainy weather throughout the morning.

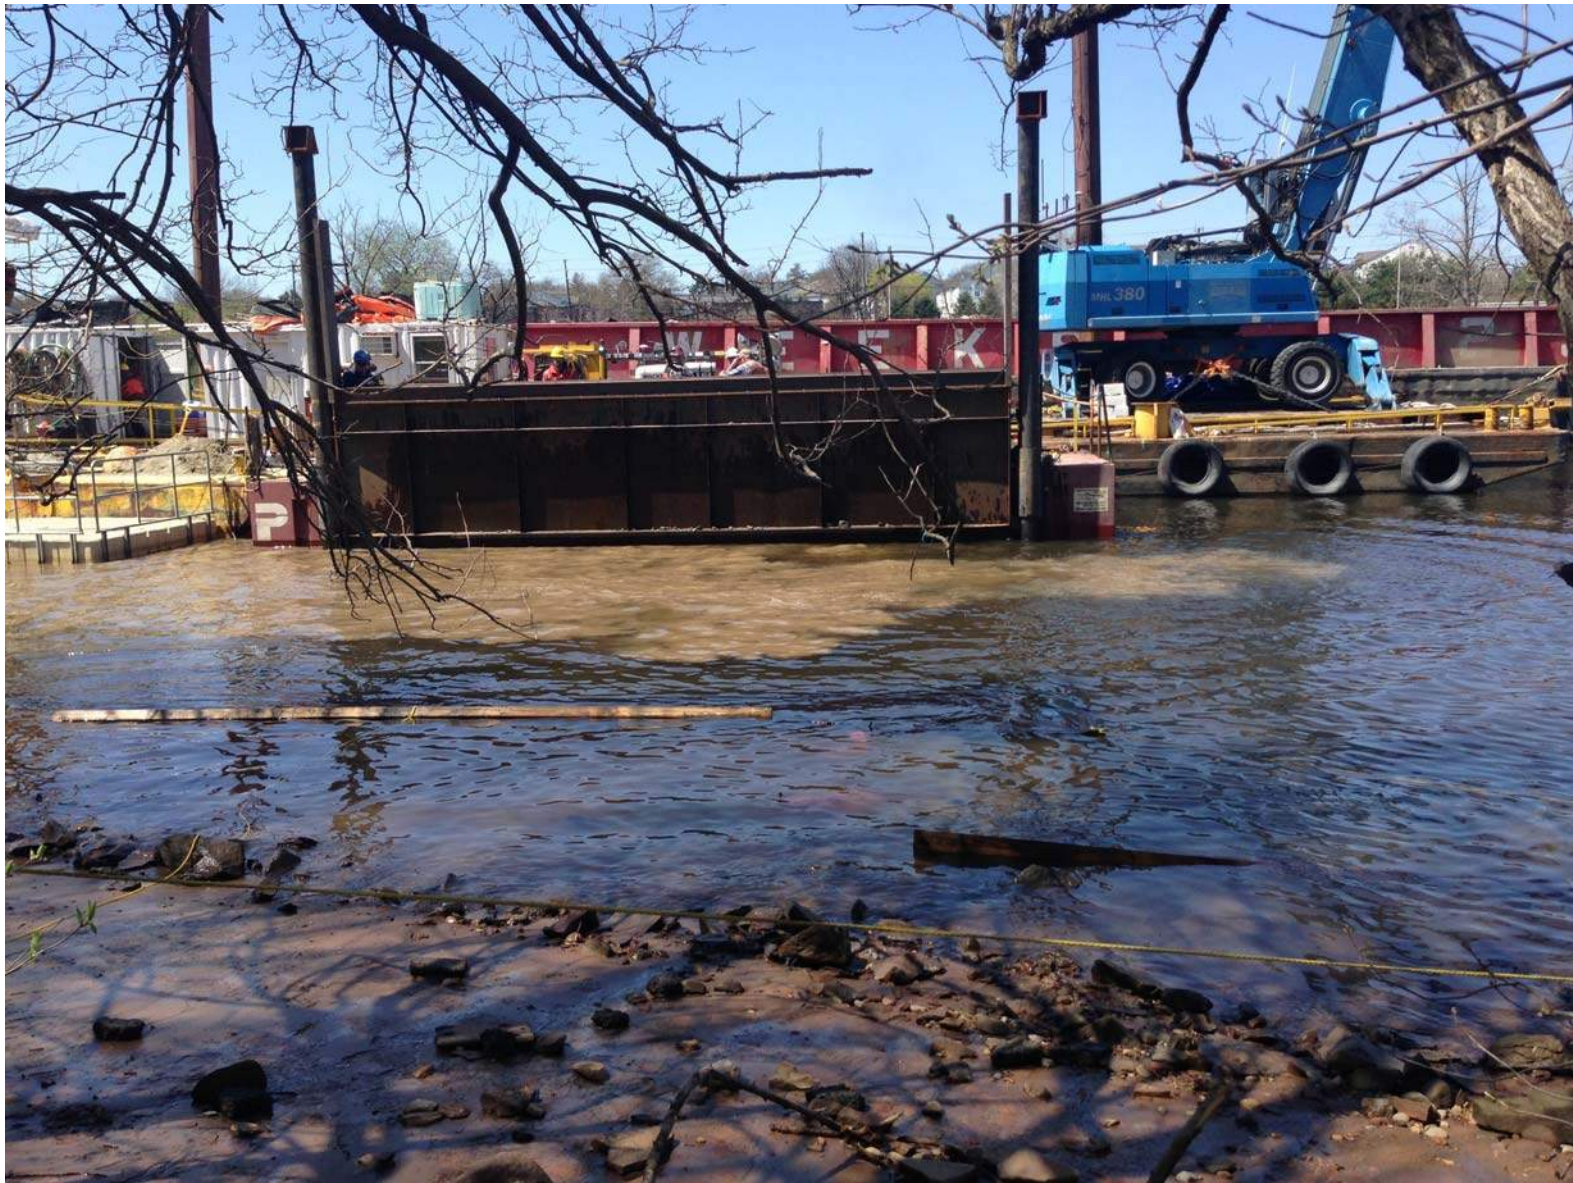
Geotextile Panel 19-S and 18-S Overlap

GLDD installed 18-S at lower tide than usual, and consequently the overlap between adjacent panels was relatively visible. Approximately three feet of overlap were observed near the shore.

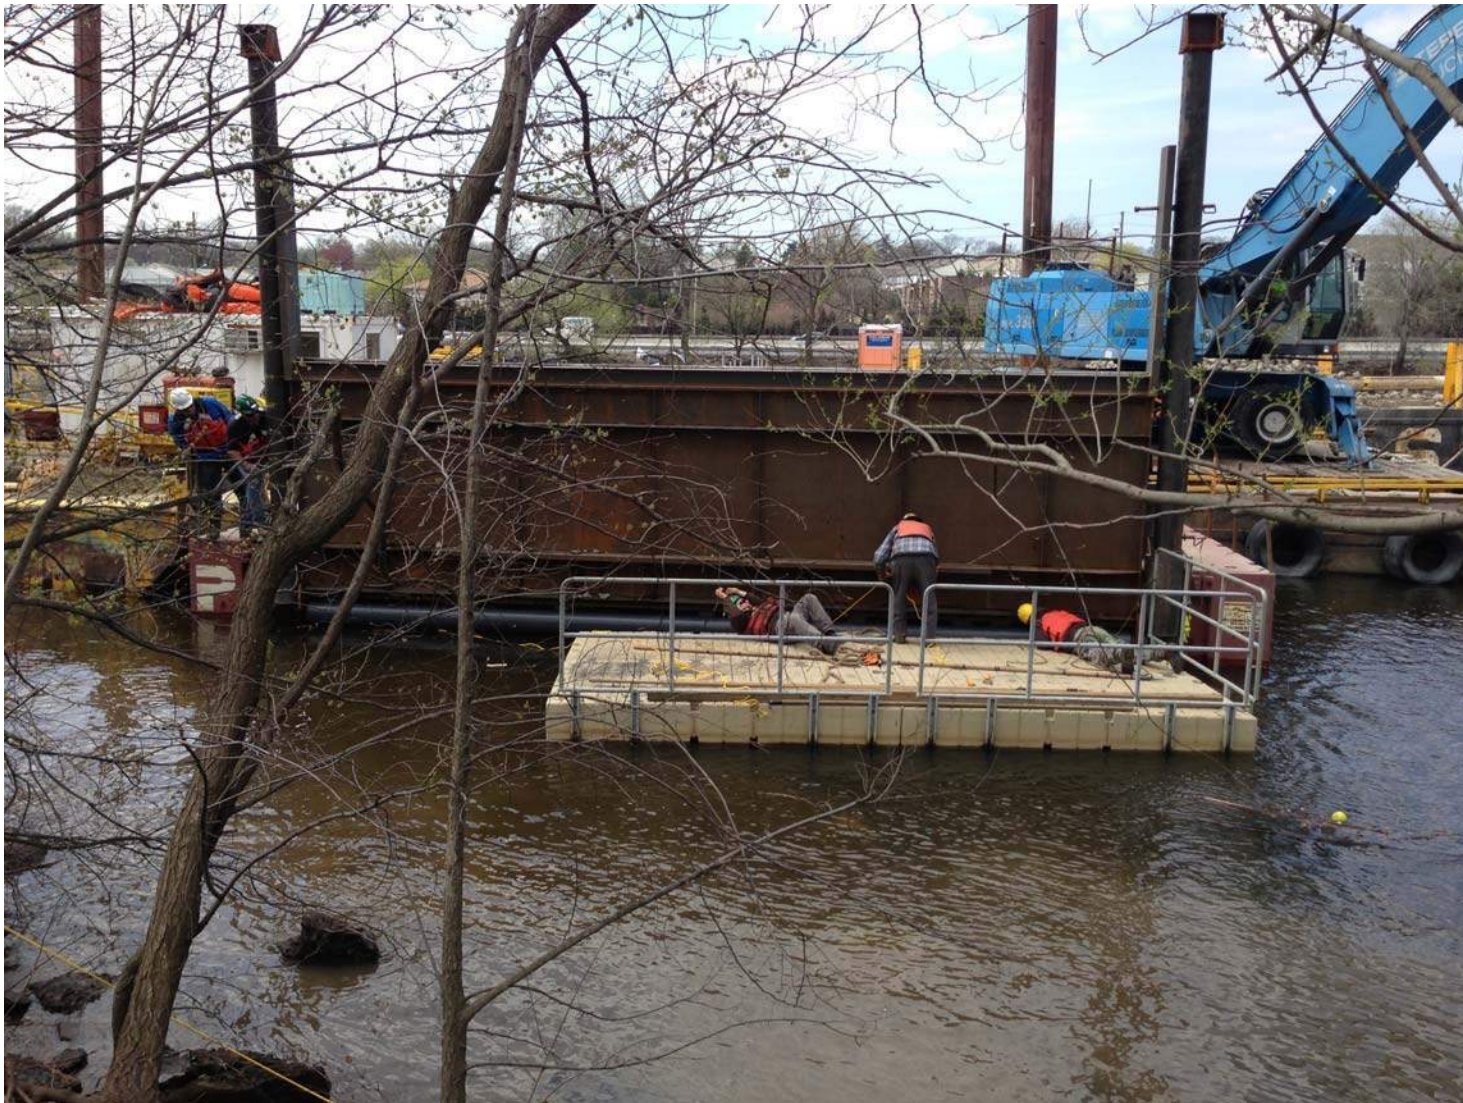
Feeding Geotextile Panel through Fabric Shroud

GLDD begin each panel by tying rope to the edge of the panel and lowering the rope down through the fabric shroud. They recover the ends of the rope (as shown above) and pull them under the rolling bar. The geotextile panel itself follows, and the ropes are tied off on trees along the shore.

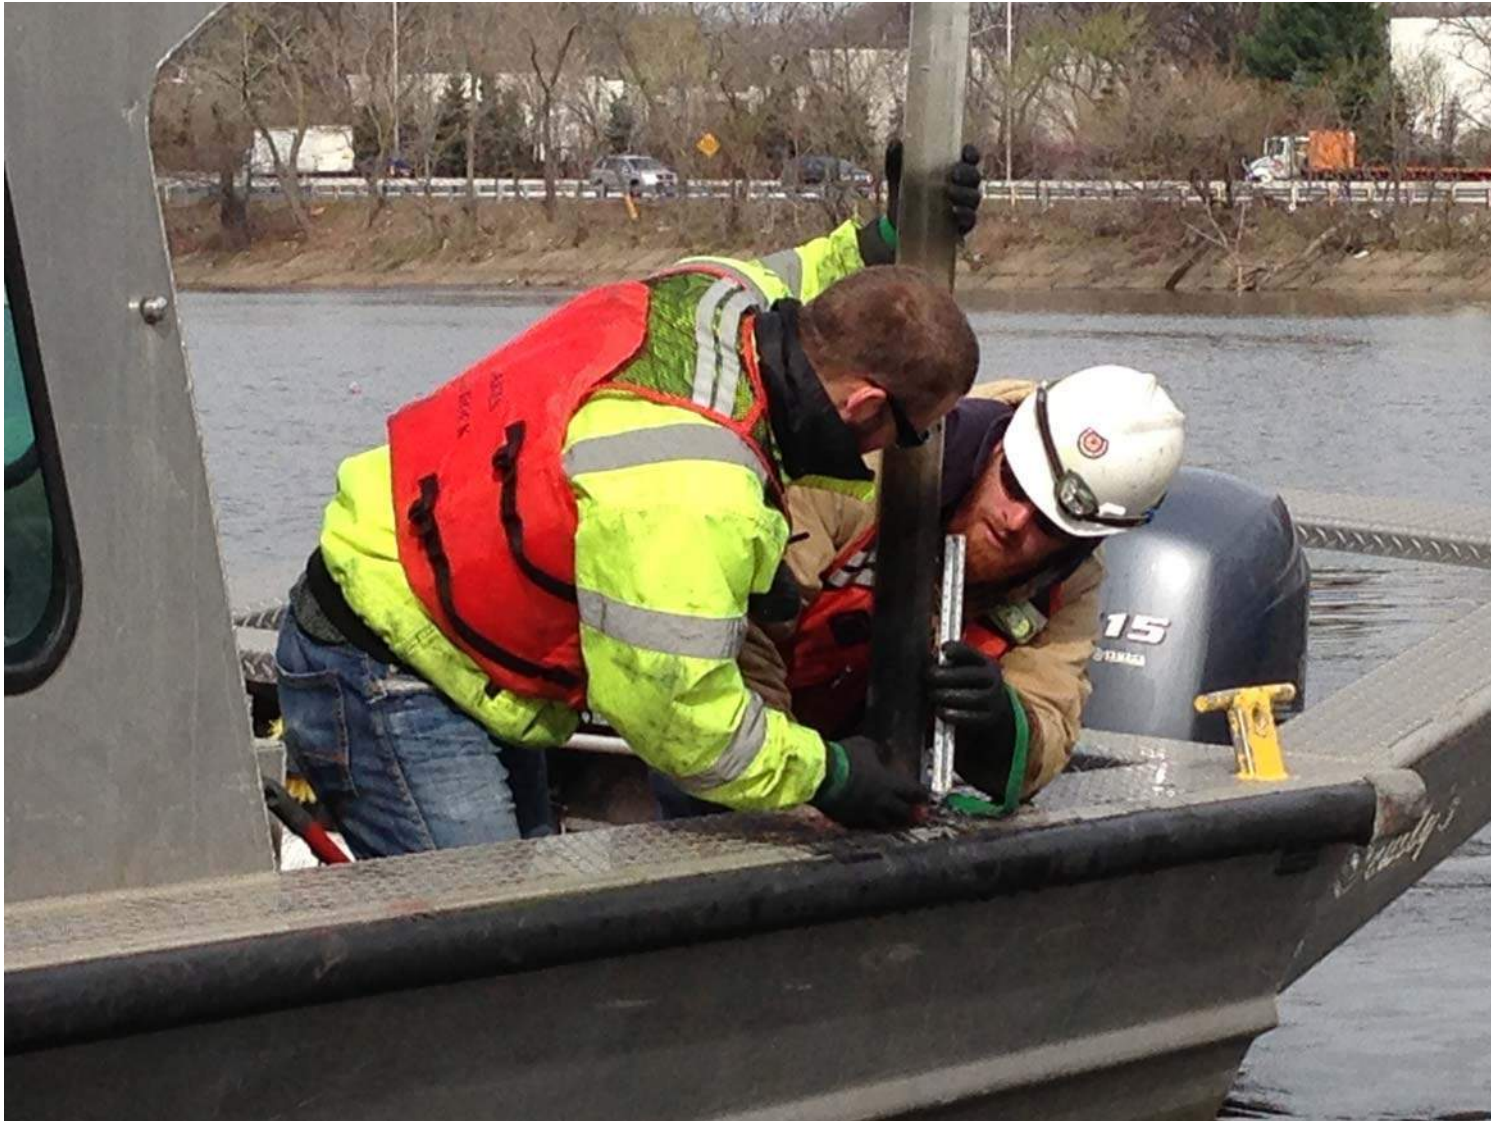
Active Layer Core Collected from 38-N

GLDD collected a sediment core from the 38-N area. The core contained approximately 11 inches of sand/AquaGate. After unsuccessful attempts to core in the 37-N area, the water level became too high to make any more attempts. They will core in the 37-N and 39-N areas on Monday morning.
